Environmental Impact Assessment Due to Gas Seepage of Titas Gas Field, Bangladesh

Abstract: The biggest gas field of Bangladesh, Titas in Brahmanbaria continues to face a possible disaster due to the seepage of the huge amount of gas mixed with water and oil through thousands of holes and cracks on the surface environment in and around this gas field. Gas is leaking through more than 3,000 big holes, including some 30-ft diameter ones, spreading in paddy fields, water bodies, and the Titas river. Approximately 1000 acres of virgin land with varieties of flora and fauna have been affected through seepage. Soil condition in the villages has degraded and still degrading to such an extent that it becomes unpredictable to comment on how many years it needs to regain fertility. Yet the present alarming situation is rippled with confusion about the actual source of seepage till now. To help the situation, an assessment of the impact of gas seepage from the Titas gas field on the surrounding environment was needed to evaluate the overall environmental condition at present and to propose adequate control measures for the abatement of the adverse impact on the environment. Therefore, the ma

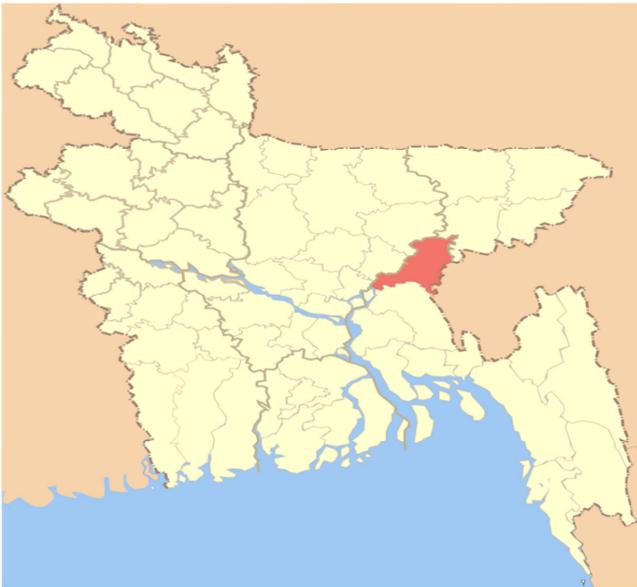
Figure 1. The geographic location of Titas gas field [17].

Bangladesh, for being a deltaic plain, is rich in her natural resources. Gas is one of the most important assets of this country. Gas fields of Bangladesh are located in Sylhet, Chatak, Rashidpur, Kailastila, Habigonj, Bharmanbaria, Begumganj and Mulavibajar [1-3]. Among these, the Titas Gas Field is the largest natural gas provider in Bangladesh lies at the outskirts of Brahmanbaria town (Figure 1). Its surroundings include the Titas river and a number of villages

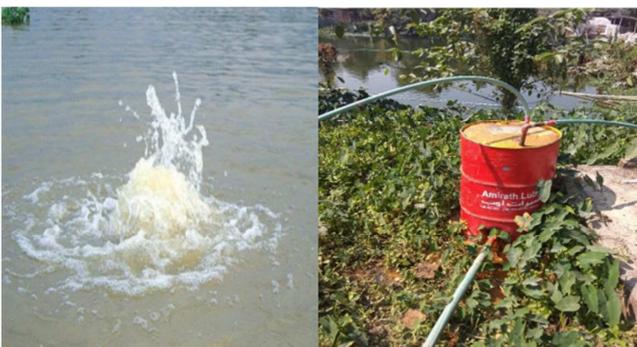
Figure 2. The gas seepage area in Shampur village [18].
